# PROPORTIONS - DISPOSITION RELATIONSHIP ANALYSIS OF A HISTORICAL TRUSS IN A RURAL HOUSE IN VÁPENNÁ VILLAGE, CZECH REPUBLIC

## Abstract

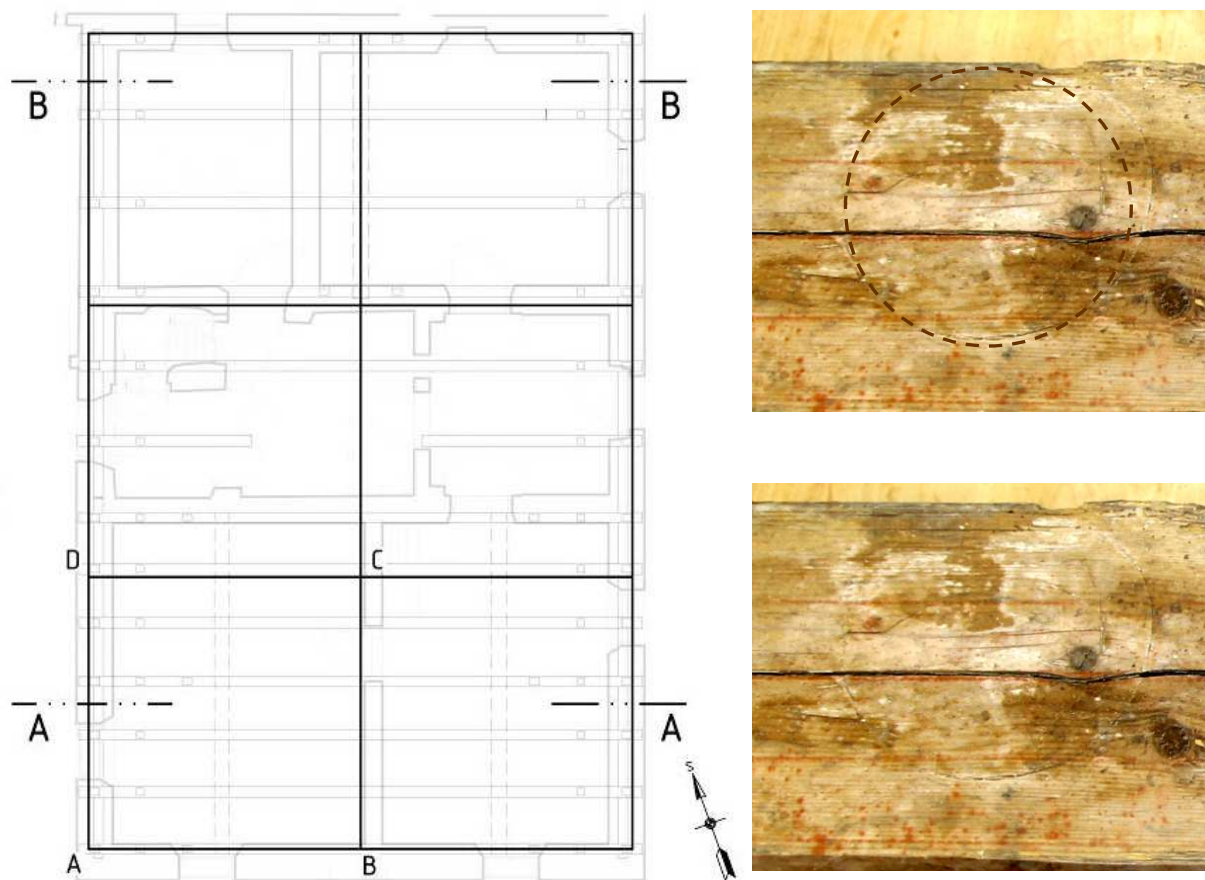
Fig. 4: (a) Floor plan; (b) Engraved circle.

For the design of the remaining important elements of buildings and trusses were formerly used a simple integer ratio, in the literature often named as “music” ratios [6, 7]. In the researched truss were used these ratios: the main collar tie is located at half of the height of the base square; upper collar tie is located at the height of the basic square; struts and rafters are placed on the tie beam in one tenth of the total width of the truss. The floor plan of the rural house (Fig. 4a) in relation to the truss is designed in such a way that the relationship between its length and width is  $3 : 2$ , this relationship expressed by a span is  $75 : 50$ . The original big front room on the South side of the house has internal dimensions in the same proportion as the entire floor plan of the house, hence the  $3 : 2$  ( $45 : 30$ ).
